SAFETY ALERT BULLETIN

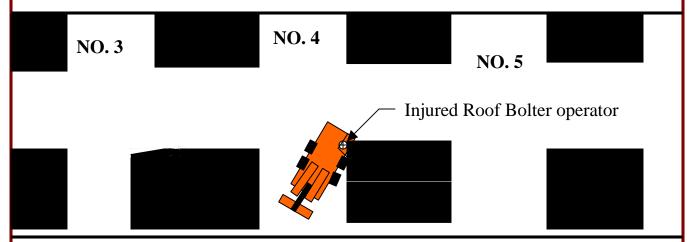
On February 8, 2004, at approximately 12:01 a.m., a Tazewell County coal miner was seriously injured when his right hand was caught between the coal rib and the operator deck frame of a Fletcher Roof Ranger 2 Roof Drill. The injured miner was transported to Bluefield Regional Hospital where he was treated and then transported to Charleston General Hospital in Charleston, West Virginia.

The injured miner was positioned in the operators compartment on his knees and was tramming the roof drill in reverse to #5 entry where he could turn the machine before moving to the face area. He had been installing belt hangers in #4 entry. As he was turning into the #4 right crosscut, the injured miner was watching the miner cable that was partially hung across the #4 entry. The victim had positioned his right hand on the outside of the deck frame when it was caught between the coal rib and the machine deck frame.

This resulted in an amputated right ring finger and fractured right little finger. The injured miner stated he felt the metacarpel gloves he was wearing saved his three other fingers from amputation.

- Never place any part of your body in a pinch point area.
- Keep all parts of your body within the confines of the operators deck at all times.
- Be constantly aware of your surroundings and if you are not sure of equipment clearance stop, de-energize your machine and look at your situation before proceeding.
